Modeling Channel Erosion in Cohesive Streams of the Blackland Prairie,

Texas at the Watershed Scale

A Thesis

Submitted to the Graduate Faculty of Baylor University in Partial Fulfillment of the Requirements for the Degree of Master of Science

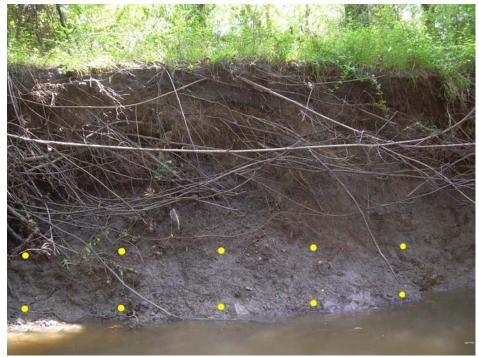
Figure 8. Photograph of the upper and lower bank erosion pin locations shown in yellow, spaced 1 m apart after Zaimes et al. 2005.

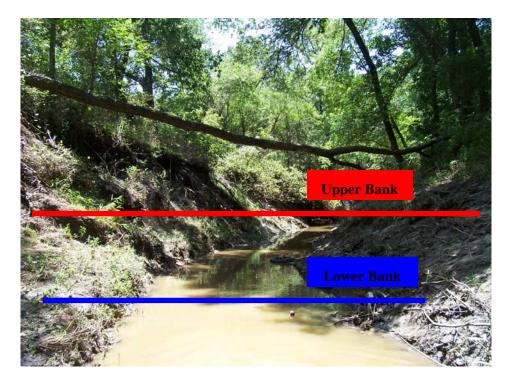
Figure 9. Photograph looking downstream at Site 2, with a drainage area of 90 km², illustrates the upper and lower bank positions within the stream channel.

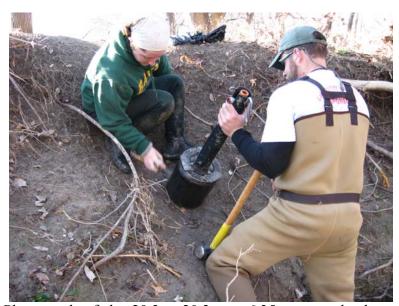
Figure 10. Photograph of the 20.3 x 20.3 cm, 6.35 mm steel tube with pneumatic extraction being placed on the upper bank to collect a soil sample for laboratory for submerged jet testing.

To evaluate stream bank erodibility, the upper and lower banks at each site were tested with the submerged jet test modified after Hanson (1990b) and Allen et al. (1997). Soil samples were collected in the field by the use of steel tube with 6.35 mm thick walls and 20.3 cm in diameter and 20.3 cm long, with pneumatic extraction (figure 10). The

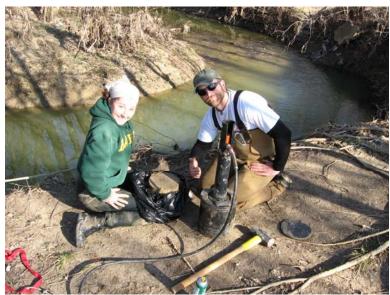
Figure 11. Photograph of the 20.3 x 20.3 cm, 6.35 mm steel tube with pneumatic extraction next to an extracted soil sample, being carefully prepared for transport back to the laboratory for submerged jet testing

soil was easily extracted from the sampler with little disturbance to obtain representative *in situ* samples. After extraction, samples were carefully prepared for transportation back to the lab for testing (Figure 11).

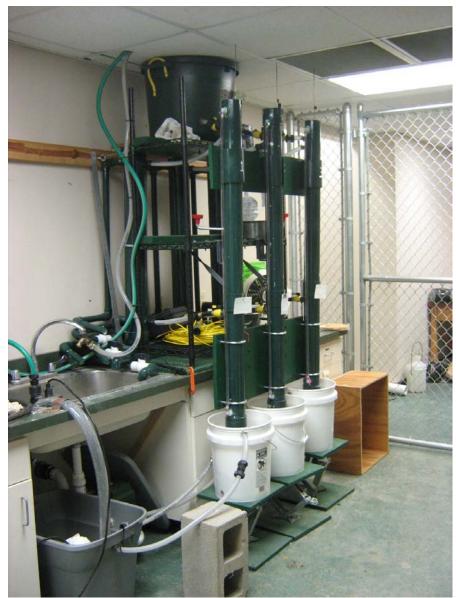
Figure 12. Photograph of the in-lab submerged jet test device (modified by Allen, Capello, and Coffman) during testing of three soil cores from the study area.

The jet test device is shown in Figure 12. The device consists of water tanks to supply pressure to the jet test with valves to vary the jet water velocity, allowing three different soil samples to be processed simultaneously. To attain distances of scour depths, the jet was stopped at ten minute intervals and a point gage tip with the same diameter as the nozzle was used to make the measurement. Tests were conducted with water that was recycled though the system with a varying conductivity between $400 - 600 \,\mu\text{S/cm}$. Each soil sample was run at a different head setting, with the head settings ranging from 38.74 - 64.14 centimeters, which corresponds to a jet velocity of 2.75 to $3.55 \,\text{m/s}$. Results from the jet test produced a single erodibility coefficient.

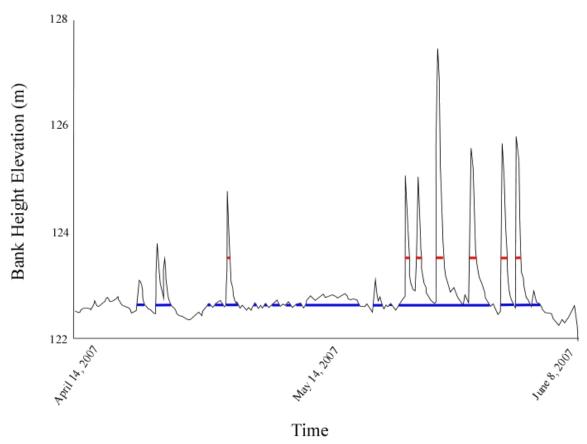
Figure 14. Hydrograph data from the HOBO® Data Logger at study site 5 for the first event monitored during April 14, 2007 through June 8, 2007. The blue line is cumulative flow duration of 230 hours and the red line is cumulative flow duration of 68 hours at the lower and upper bank locations respectively.

Analysis of the water level loggers permitted calculation of the durations when flow of water was at the studied pin heights for lower and upper bank (Figure 14). This was termed the *wetting duration*. The wetting duration was then tabulated for each monitored event. Bank shear at water level was calculated with WinXSPRO version 3 (Hardy et al., 2005) which computes based on the surveyed bank dimensions, bank heights, water surface slopes, radius of curvatures, and side shear (Table 1). The bank loss and wetting durations were then summed at each site for the entire monitoring period (Table 4). Site 6 was removed from the study due to cattle disturbances. Cumulative

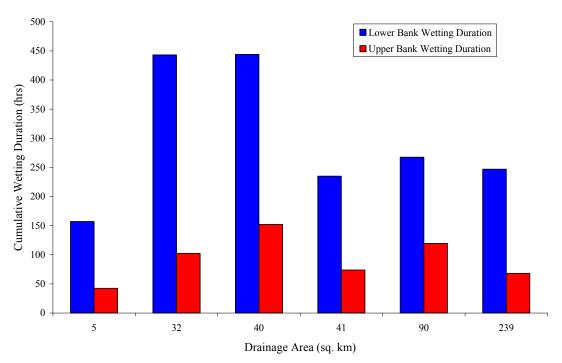
Figure 15. Cumulative wetting duration for a one year monitoring period compared to the drainage areas of the study sites. The lower bank wetting duration is on average 70 percent greater than the upper bank.

wetting durations at the lower bank locations were on average 70 percent greater than those experienced at the upper bank locations (Figure 15). Cumulative bank losses were similar for watershed less than 90 square kilometers, but were 22 percent greater in the upper bank location at the larger watershed (Figure 16). The sediment loss (mm) and the flow durations (hrs) yielded a sediment loss rate (mm/hr) for the three monitored events for the lower and upper bank locations at each site (Table 5).

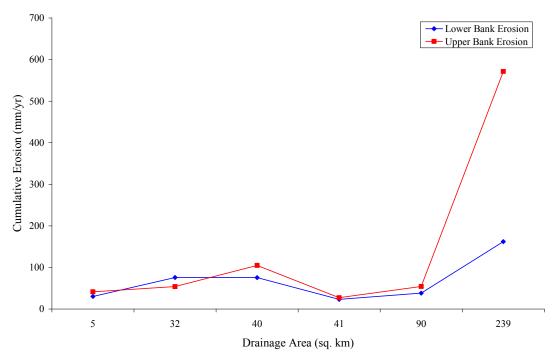
Figure 16. Cumulative erosion rate at the lower and upper bank locations for a one year monitoring period compared to the drainage areas of the study sites. The upper bank erosion rates are 22 percent greater than the lower bank in drainage areas greater than 90 square miles.

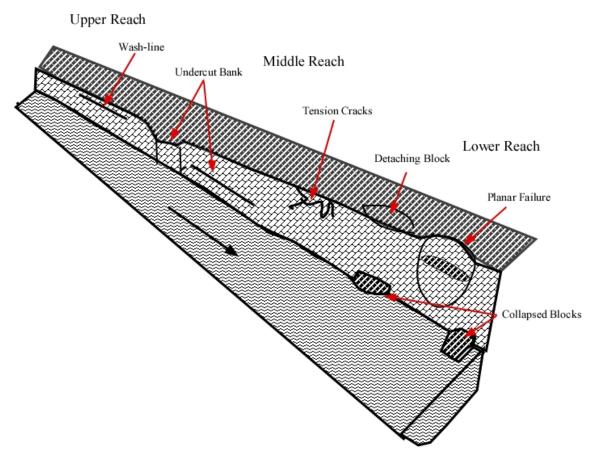
Figure 17. A schematic representation of downstream changes in dominant river bank erosion processes. Figure modified after Lawler (2004).

occur within each section (*e.g.* upper, middle and lower reaches). The upper reaches represent the headwaters zones, which are dominated by the weathering process known as a wash-line, where subaerially loosened sediment has been washed off by flowing water (Prosser et al., 2000). Bank heights are too low for mass failure processes (Lawler, 2004). The middle reaches are dominated by fluvial entrainment, derived from declining slopes and increasing discharges, which undercut banks and cause tension cracks (Lawler, 2004). The lower reaches are dominated mass failure processes, which are linked to fine-grained banks of large unit weight (Lawler, 2004). Mass failure processes include: detaching blocks, planar failures and collapsed blocks.

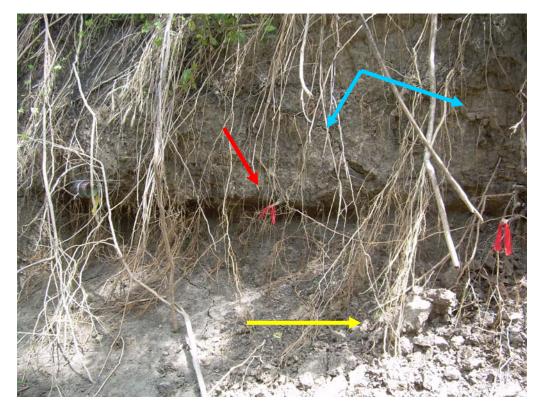
Figure 18. Photograph of the upper bank at Site 7 (drainage area 239 km²). The erosion pins are marked with red flagging tape (red arrow) where the bank is being undercut by water flow. The photograph shows tension cracks (blue arrows) and fallen bank material (yellow arrow).

Site 7, with the largest drainage area (239 km 2), displays the processes illustrated in the lower reaches of Lawler's (2004) schematic (Figure 18). Tension cracks, planar failures, collapsed blocks were observed at Site 7, which had the largest erosion rates of 162 - 572 mm/yr.

During the monitoring period tension cracks were observed that are inferred to result from soil dessication. These tension cracks reduce the structural strength of a stream bank (Thorne, 1982). Cycles of wetting and drying influence bank erodibility (Knighton, 1973), decreasing the aggregate size (Shiel et al., 1988), and make the soil more susceptible to erosion during storm events.

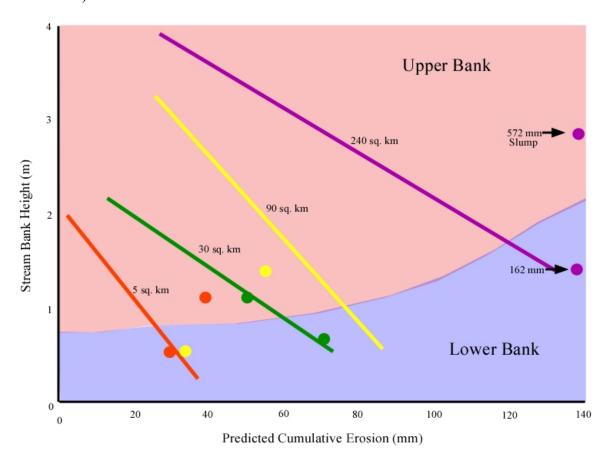
Figure 19. Diagram showing the predicted erosion obtained from the submerged jet test (lines) and the actual rates (circles).

This research is the first to demonstrate that erosion rates can be predicted (Figure 19) by the use of a submerged jet test. This was accomplished by field *in situ* methods using erosion pins and water level loggers. Hanson (1990) performed flume studies to obtain loss rates to compare to the rates resulting from the submerged jet test (ASTM D5258-95).

This diagram indicates predicted erosion for the study sites based on flow duration and bank position. Each line in Figure 19 is in the form of:

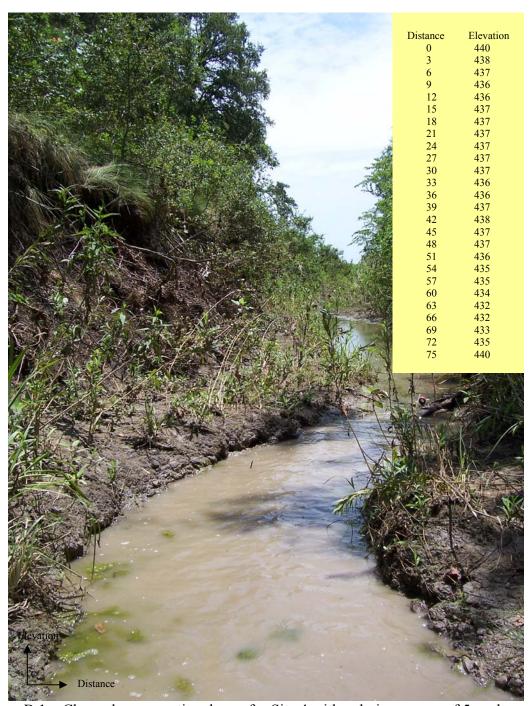
Figure B.1. Channel cross sectional area for Site 4 with a drainage area of 5 sq. km.

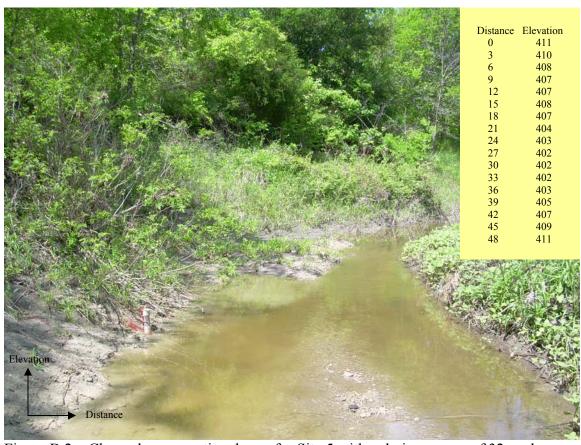
Figure B.2. Channel cross sectional area for Site 5 with a drainage area of 32 sq. km.

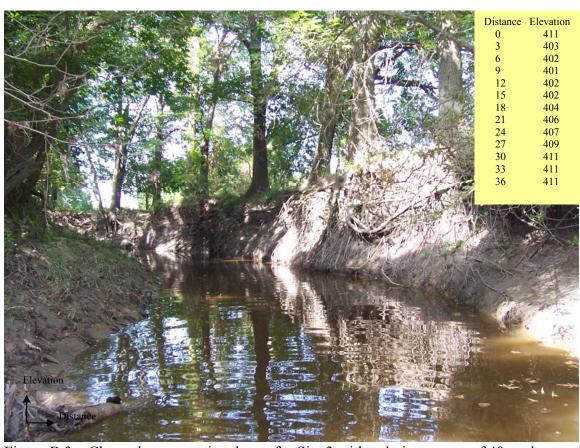
Figure B.3. Channel cross sectional area for Site 3 with a drainage area of 40 sq. km.

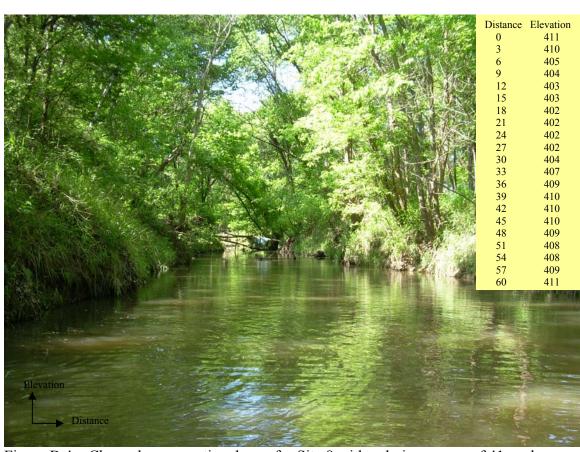
Figure B.4. Channel cross sectional area for Site 8 with a drainage area of 41 sq. km.

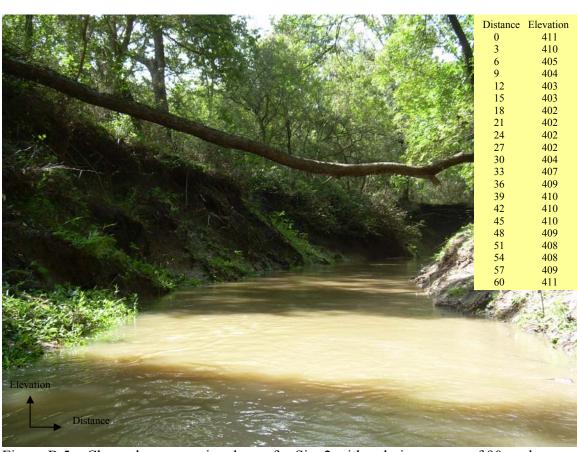
Figure B.5. Channel cross sectional area for Site 2 with a drainage area of 90 sq. km.

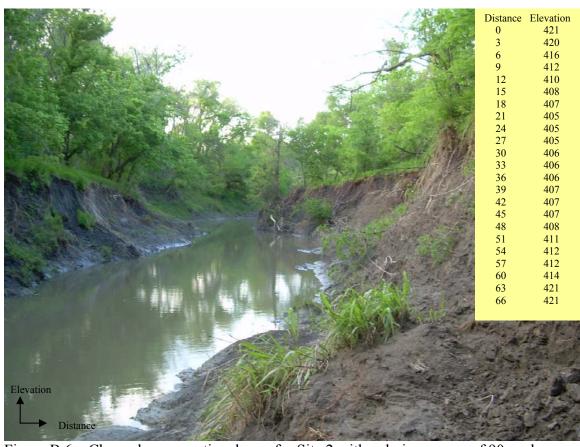
Figure B.6. Channel cross sectional area for Site 2 with a drainage area of 90 sq. km.

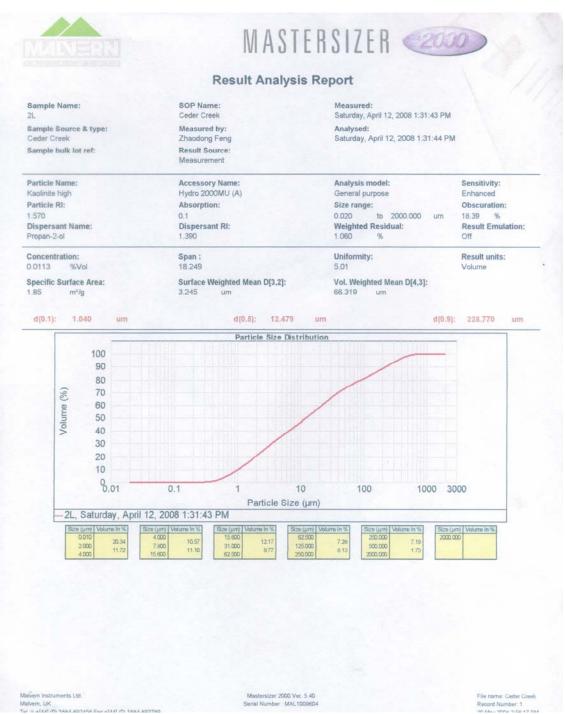
Figure D.1. Grain size analysis of the lower bank at site 2.

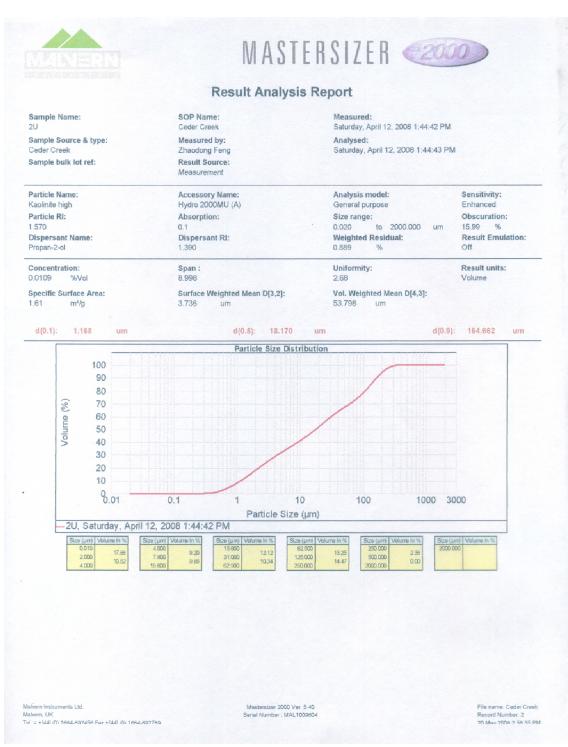
Figure D.2. Grain size analysis of the upper bank at site 2.

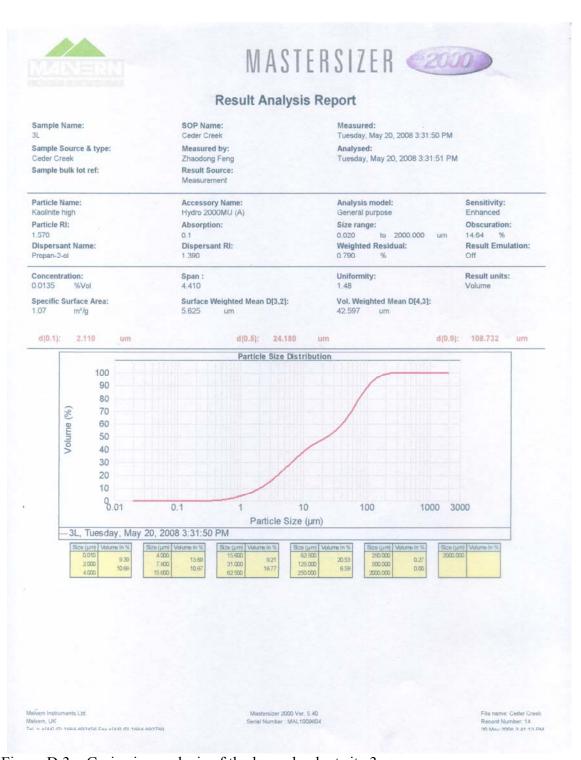
Figure D.3. Grain size analysis of the lower bank at site 3.

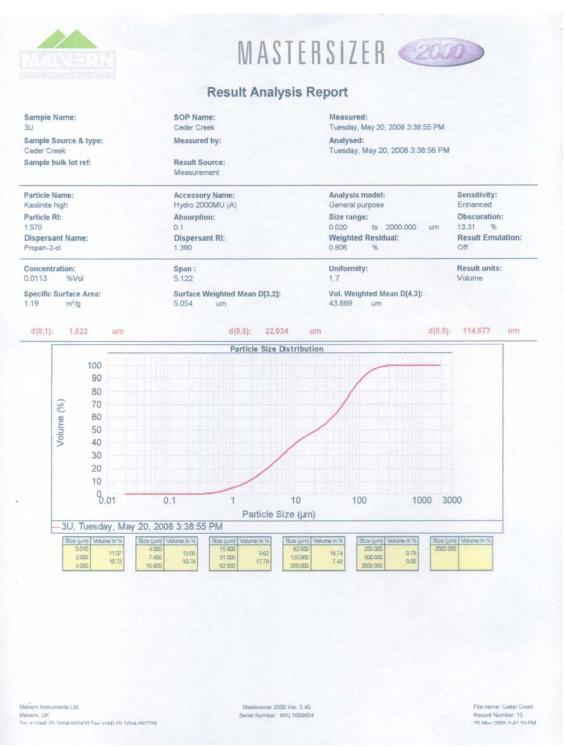
Figure D.4. Grain size analysis of the upper bank at site 3.

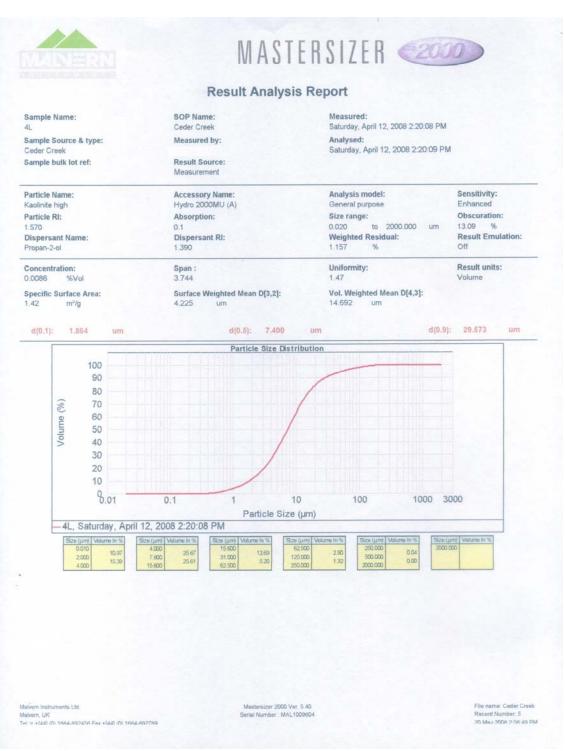
Figure D.5. Grain size analysis of the lower bank at site 4.

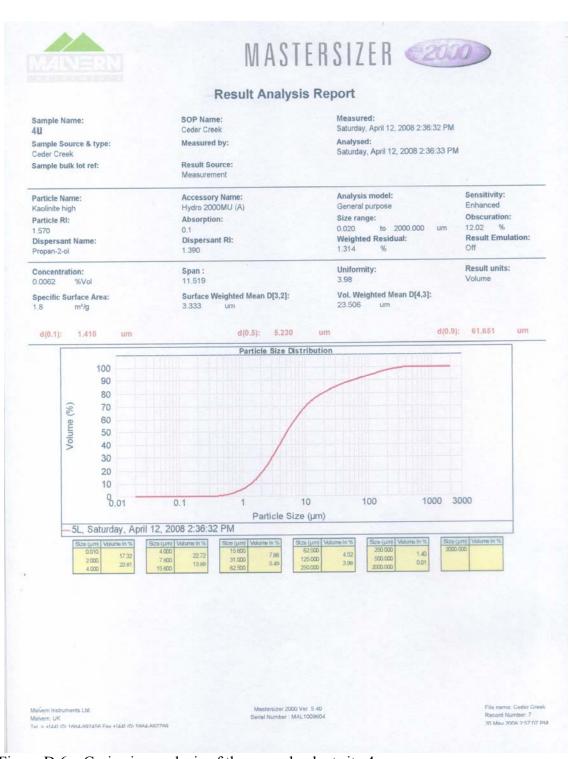
Figure D.6. Grain size analysis of the upper bank at site 4.

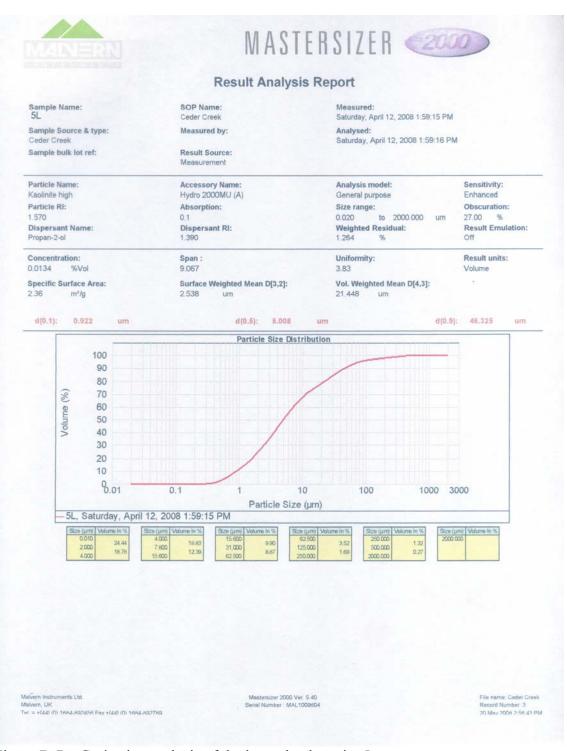
Figure D.7. Grain size analysis of the lower bank at site 5.

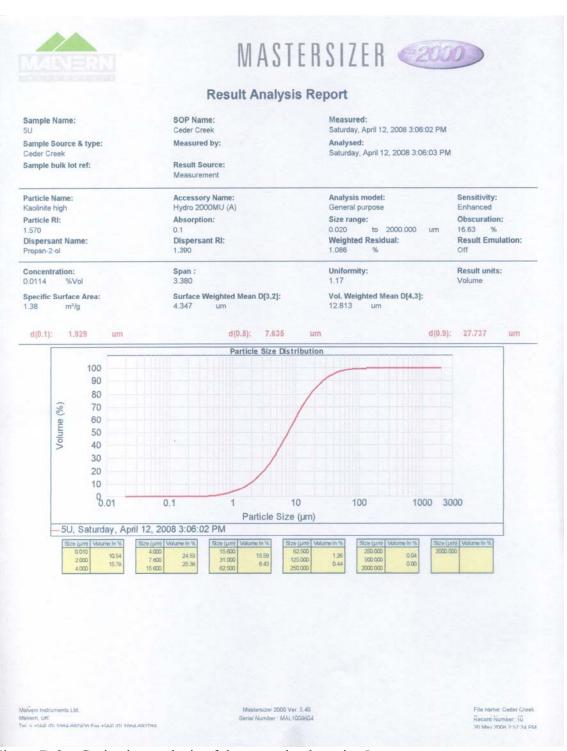
Figure D.8. Grain size analysis of the upper bank at site 5.

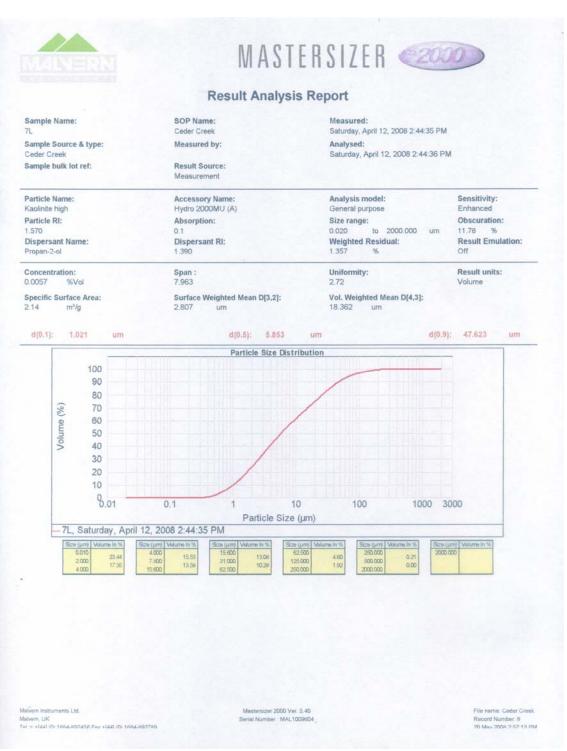
Figure D.9. Grain size analysis of the lower bank at site 7.

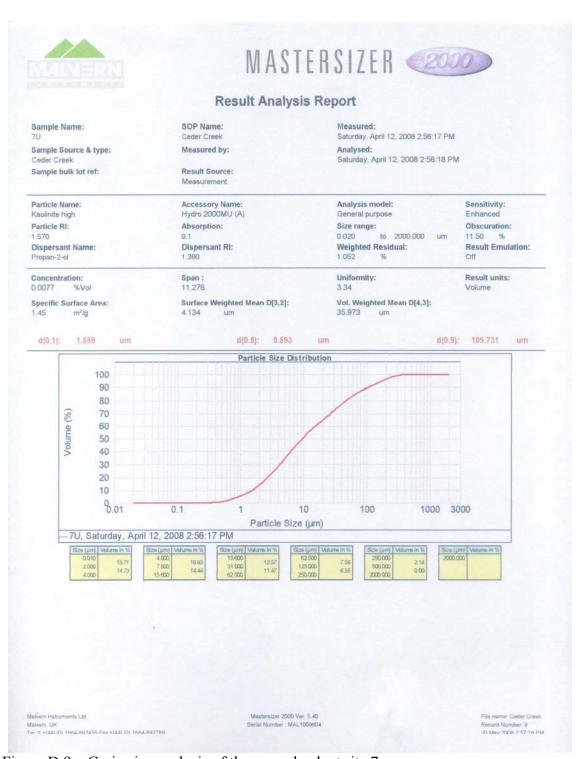
Figure D.9. Grain size analysis of the upper bank at site 7.

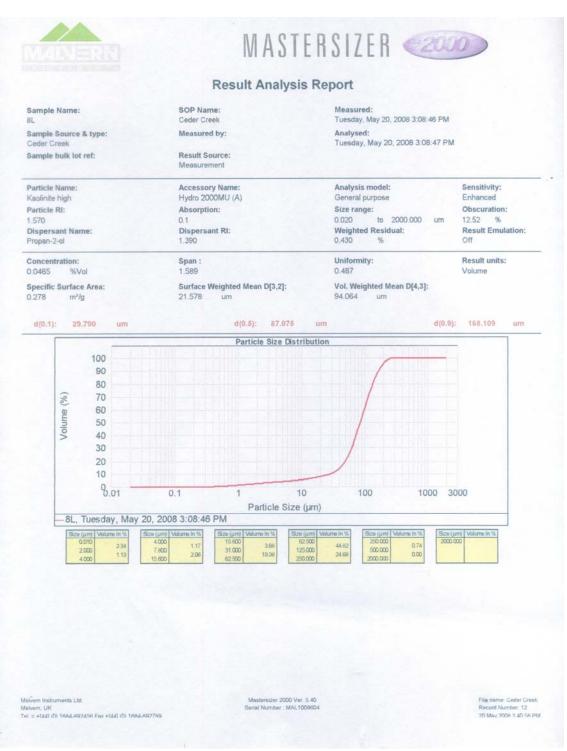
Figure D.11. Grain size analysis of the lower bank at site 8.

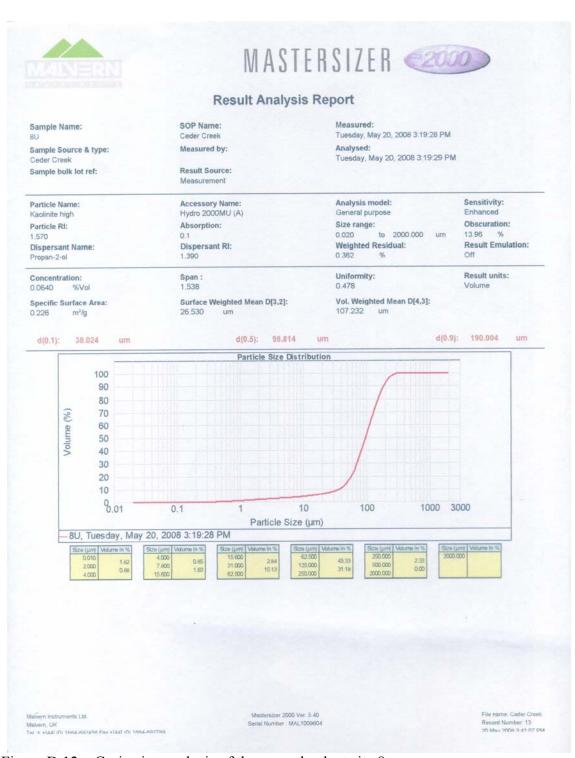
Figure D.12. Grain size analysis of the upper bank at site 8.
